Decorative Plasterwork at Volvveti Manor

—Sustainable Heritage Report No. 6

Traditional Wooden and Masonry Structures in the Baltic Sea Region
Sustainable Heritage reports, 2/2014

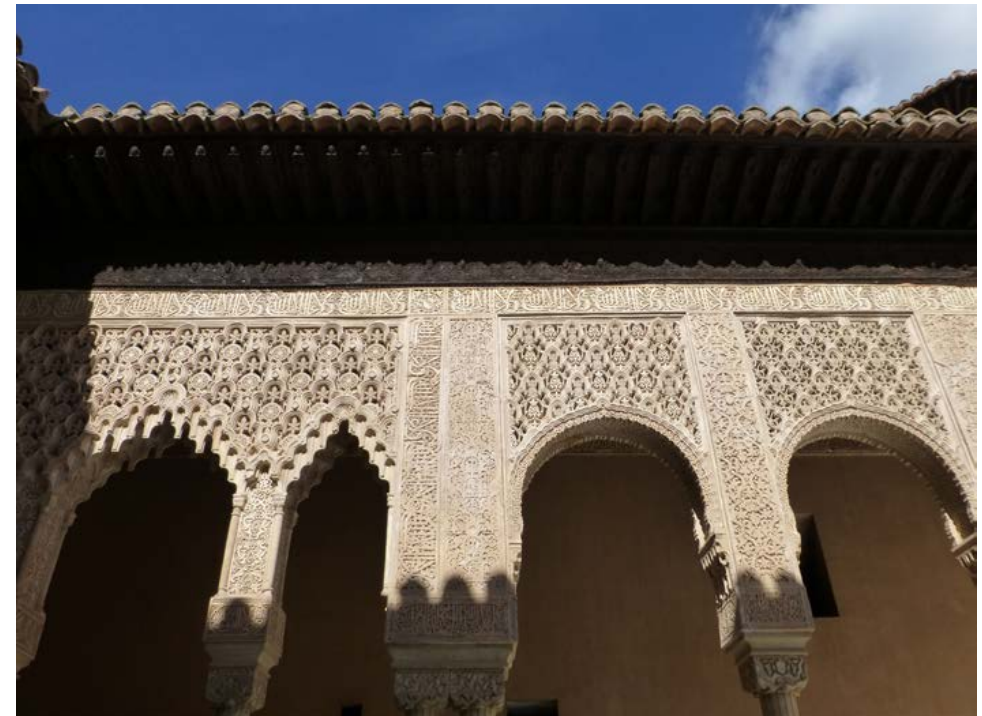
Figure 1.1. Detail of plasterwork with Islamic themes that cover the walls and ceilings of Alhambra Palace. Photograph by Kirsti Horn.

Gypsum or lime plaster was used for bas reliefs and sculpture already in ancient Egypt, the Middle East and in antique Greece and Rome but then largely forgotten during the Middle Ages in Europe apart from Germany and Silesia. Its use lived on in the Islamic world where architectural masterpieces were often covered in lime plaster and decorative plasterwork inside and out. There are two notable examples of this in southern Spain, the palace of 14th century Alhambra being the more famous and one of the first UNESCO World Heritage Sites (figure 1.1).

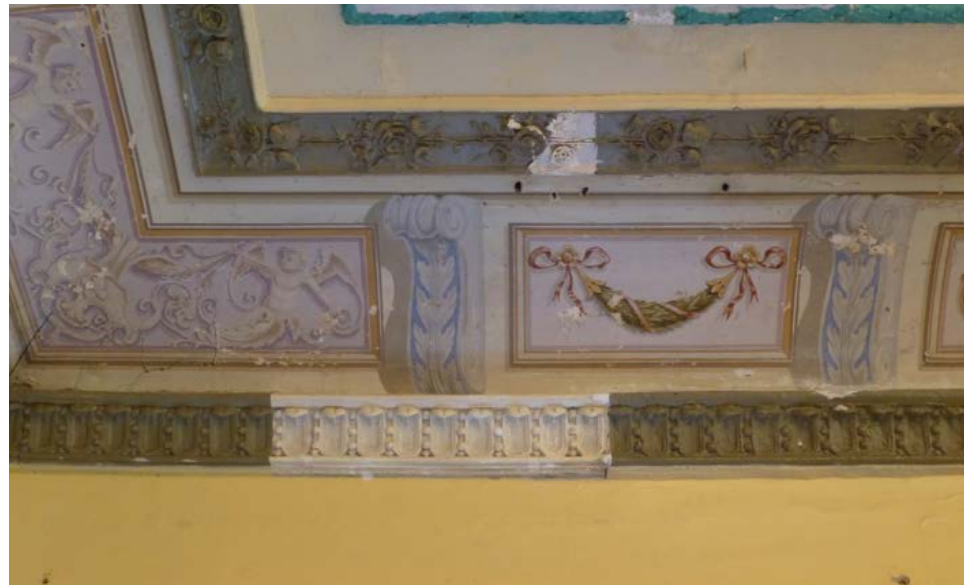
Figure 1.2. The cornice of the ballroom in Voltveti manor consists of three lines of decorative plasterwork and trompe l'oeil painting with consoles, putti and garlands in between. Photograph by Kirsti Horn.

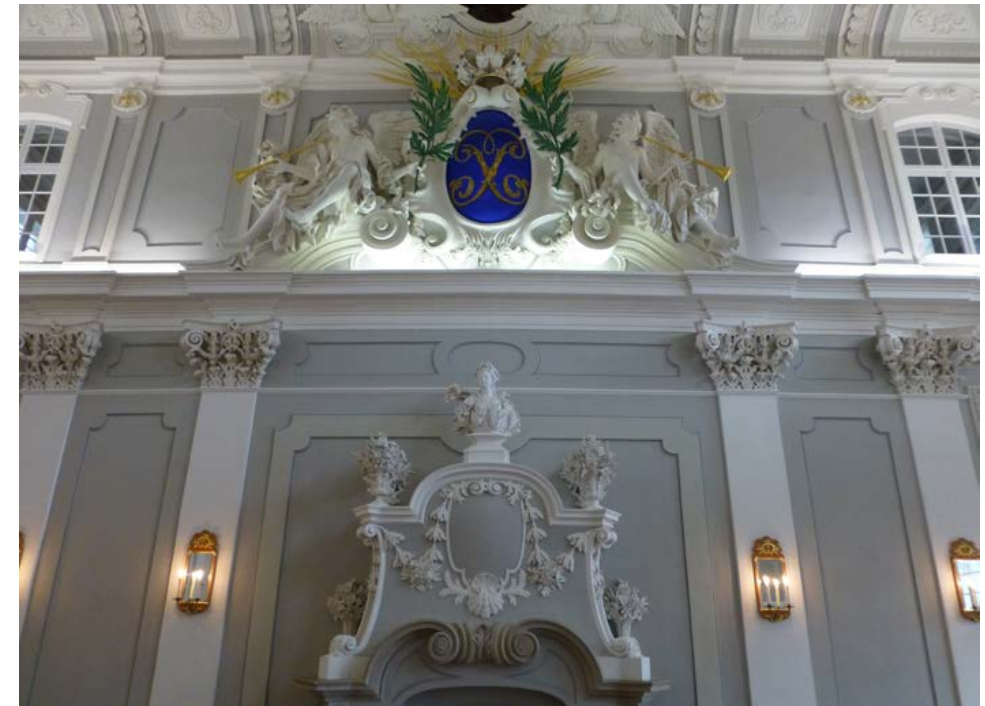
Figure 1.3. Baroque and Rococo themes can be detected in the plasterwork detailing at the magnificent Kadriorg Palace in Tallinn. Photograph by Kirsti Horn.

Decorative plasterwork was used as a means for making optical illusions in Baroque and Rococo interiors. The plaster putti, pompous mouldings, medallions, garlands and copies of antique detailing were used as a link between architectural elements and illusionistic ceiling paintings that made *trompe l'oeil*, or deceiving the eye, possible (figure 1.2). Ceiling paintings create the scenery (sky with clouds and figures, for example) and the imaginative plasterwork frames it with architectural essence and figurative compositions which seem to grow out of the walls (figure 1.3).

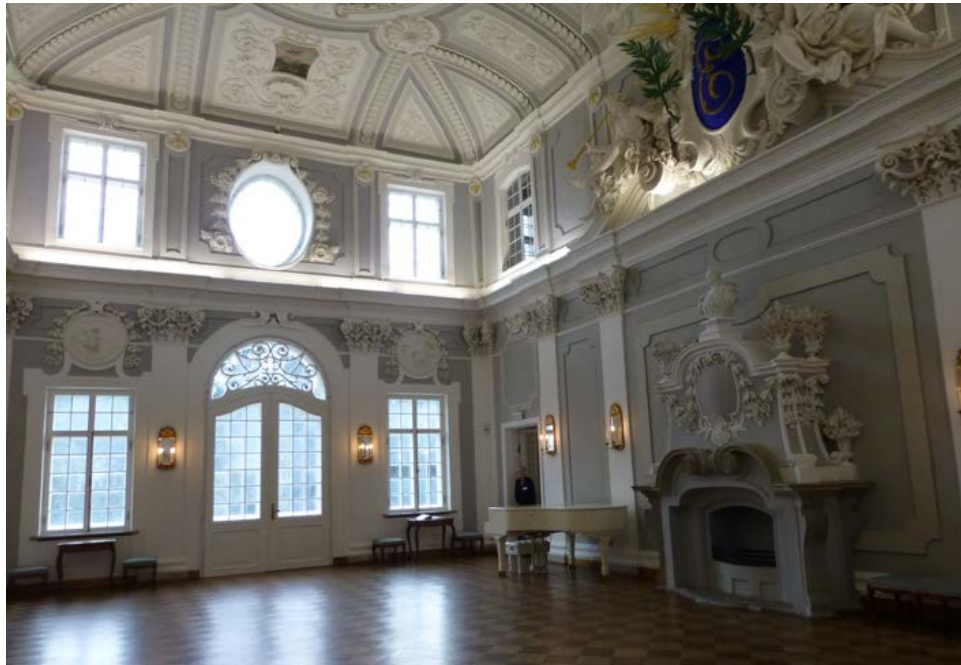
Figure 1.4. The banqueting hall of Kadriorg Palace in Tallinn dates back to the early 18th century. Photograph by Kirsti Horn.

The finest examples of late Baroque interiors are in Kadriorg Palace in Tallinn which was completed in the 1720's (figure 1.4). Matthias Seidtinger from Riga and the Italian master Antonio Quadri decorated the main hall which has survived as a whole. Originally there were decorative plasterwork and painted ceilings in the other rooms, as well.

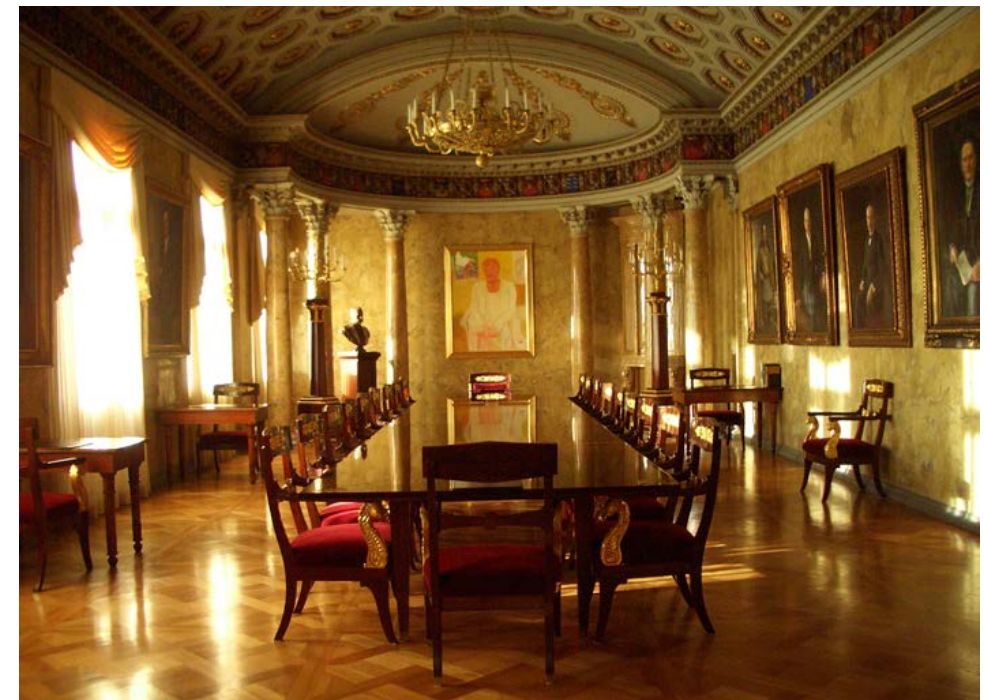
Figure 1.6. The throne hall in the Senate Building in Helsinki, 1822 with decorations and furniture designed by Carl Ludvig Engel. Photograph by Kirsti Horn.

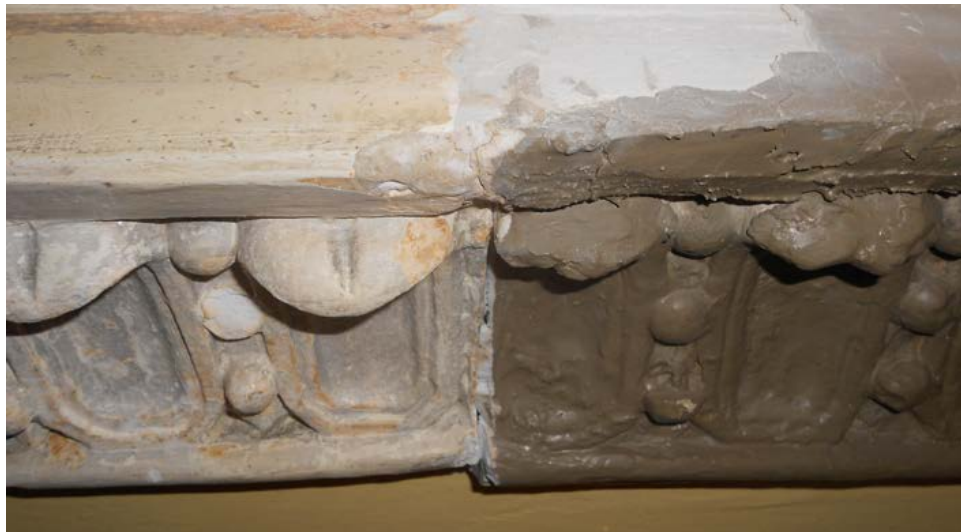
Most of the damages of the plasterwork were mechanical in the grand hall of Voltveti manor. This is not surprising, as the room has been used as a multi-activity space during the last 70 years. All the decorative plasterwork was covered with several layers of paint. This not only distorts the shape of the designs but also covers all smaller damages, cracks and earlier repairs. Parts of cornices had fallen down in some places and been repaired incorrectly (figure 2.2). Around some broken areas there was also danger of collapse. The seven *putti* with musical instruments had suffered some material loss and damages, and a couple of their heads had been replaced with incorrect pieces made of bad quality plaster (figure 2.3). The acanthus leaves in the corners of the wall panels had lesser mechanical damages (figure 2.4).

Figure 2.2. The removal of paint revealed bad joints between the precast sections. Photograph by Kristiina Ribelus.

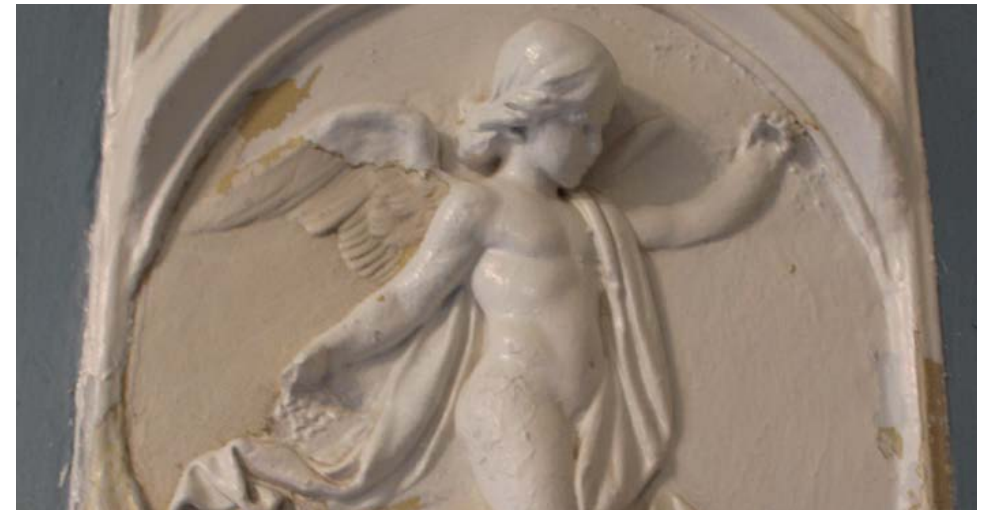
Figure 2.3. This putto has lost his instruments. Photograph by Triin Jänes.

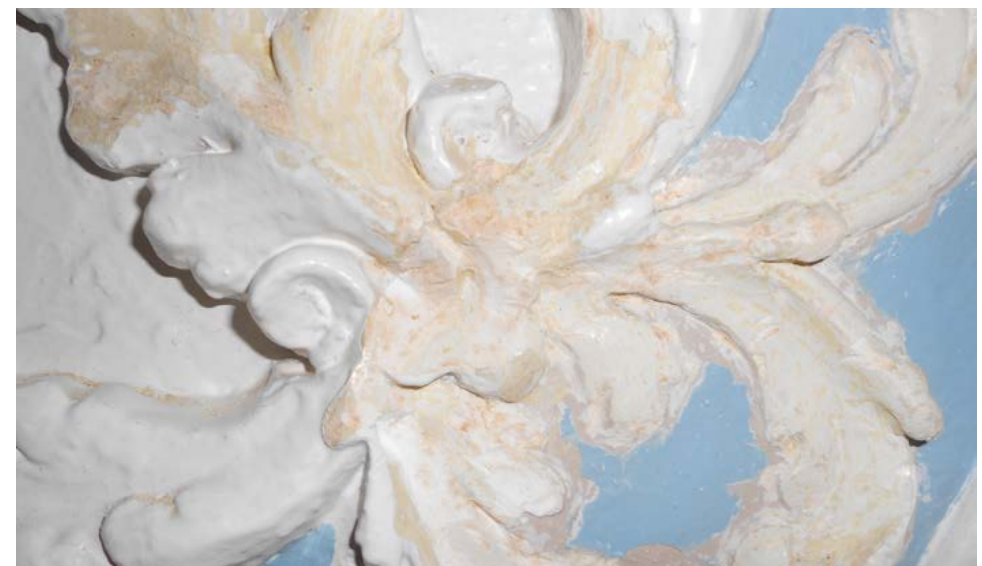
Figure 2.4. At a close look all acanthus leaves were slightly different: they had been modelled in situ. Most of them had suffered several blows. Photograph by Kristiina Ribelus.

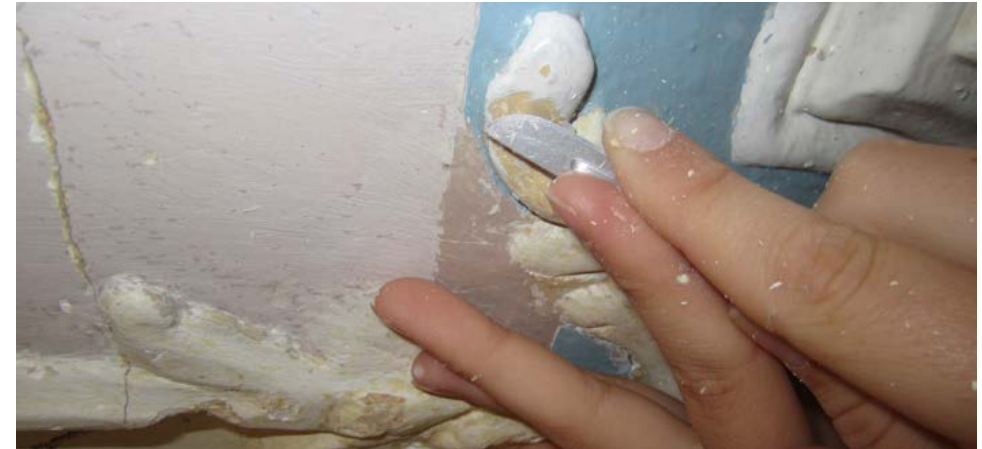
Figure 2.5. Working with a scalpel. Photograph by Sandra Heinström.

The most reliable method of paint removal techniques is the mechanical, and the most important tool is a scalpel (size 10 and 21 were used in Voltveti). This small and very sharp knife is excellent for scraping excess paintwork. A small brush is used for removing dust and flakes of dirt and paint during and after the cleaning process. When removing old paintwork it is important to use goggles because sharp flakes of old paintwork and dust tend to fly about on a site like this. It is also possible to remove a thin coat of paint by abrading the surface with sandpaper with a very fine grit (figures 2.5, 2.6).

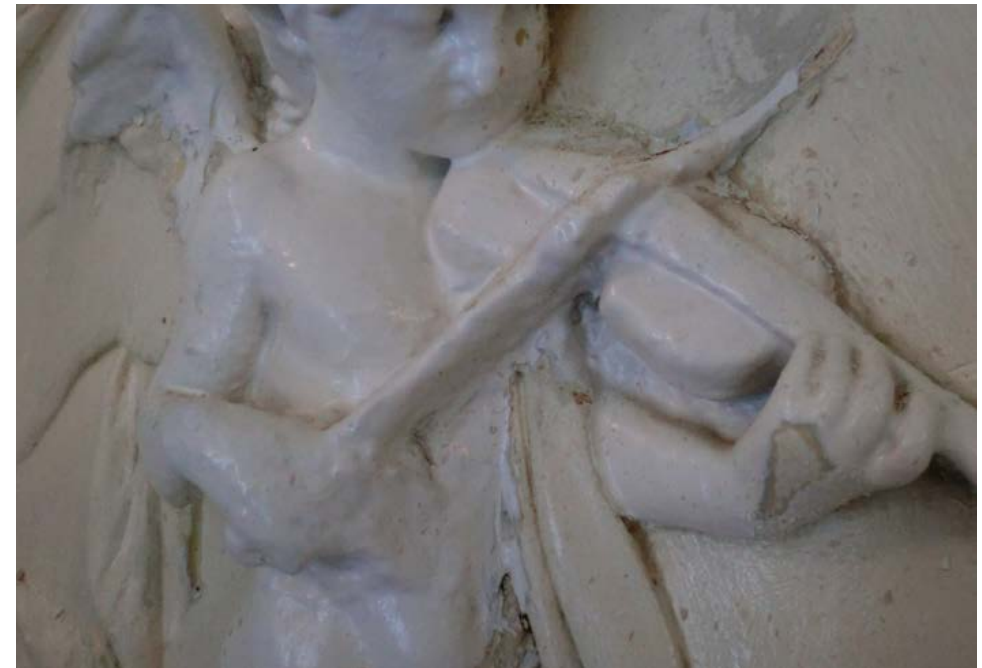
Figure 2.6. The little fiddler is slowly being recovered from his four coats of paint. Photograph by Amanda Oom.

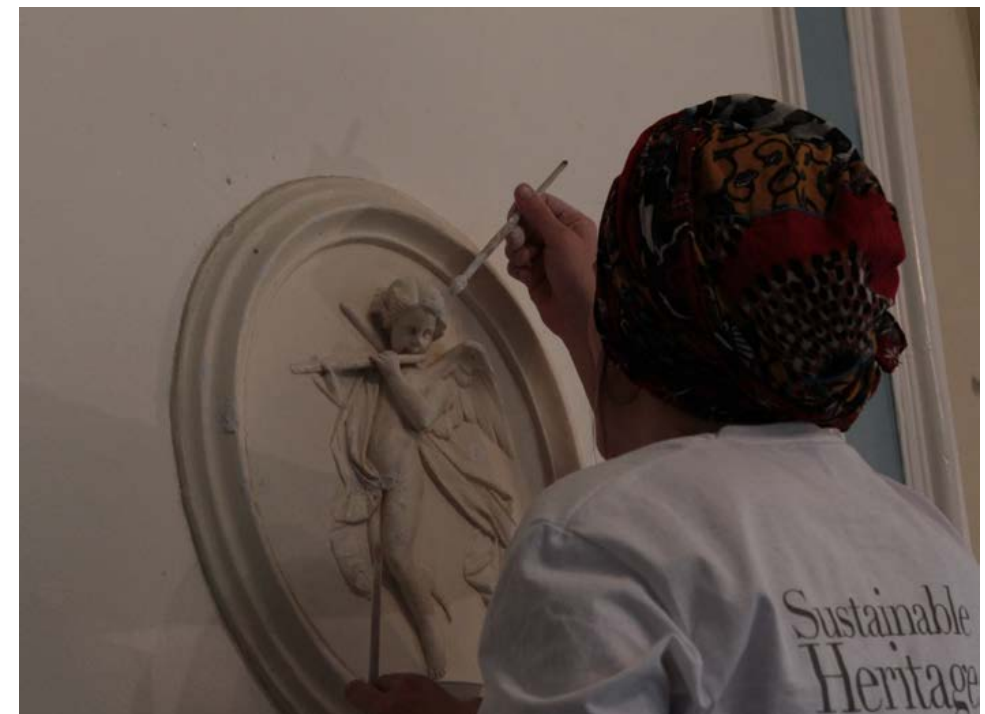
Figure 2.7. A putto is getting a face lift. Photograph by Triin Jänes.

Reparations to old decorative plasterwork are done by applying a mixture of gypsum, water and glue onto the defected parts or in order to build up a missing detail. This is done layer by layer with a soft aquarelle brush. The added material usually needs to be sanded down to fit in with the old shapes (Figures 2.7, 2.8).

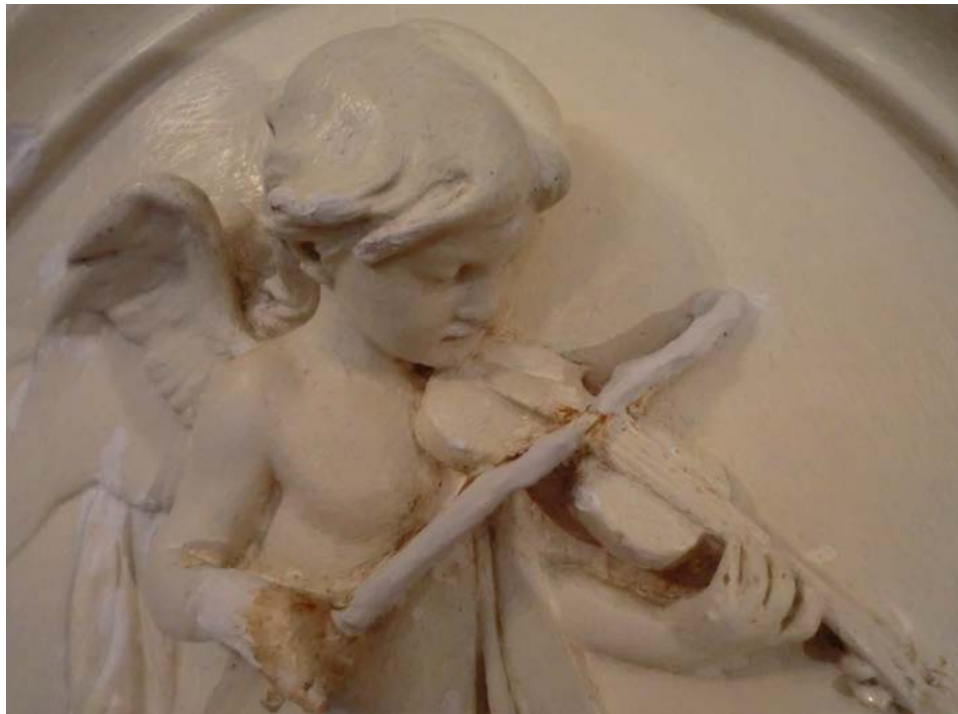
Figure 2.8. The white patches are new plaster, not yet sanded down. The bow has not been cleaned yet. Photograph by Amanda Oom.

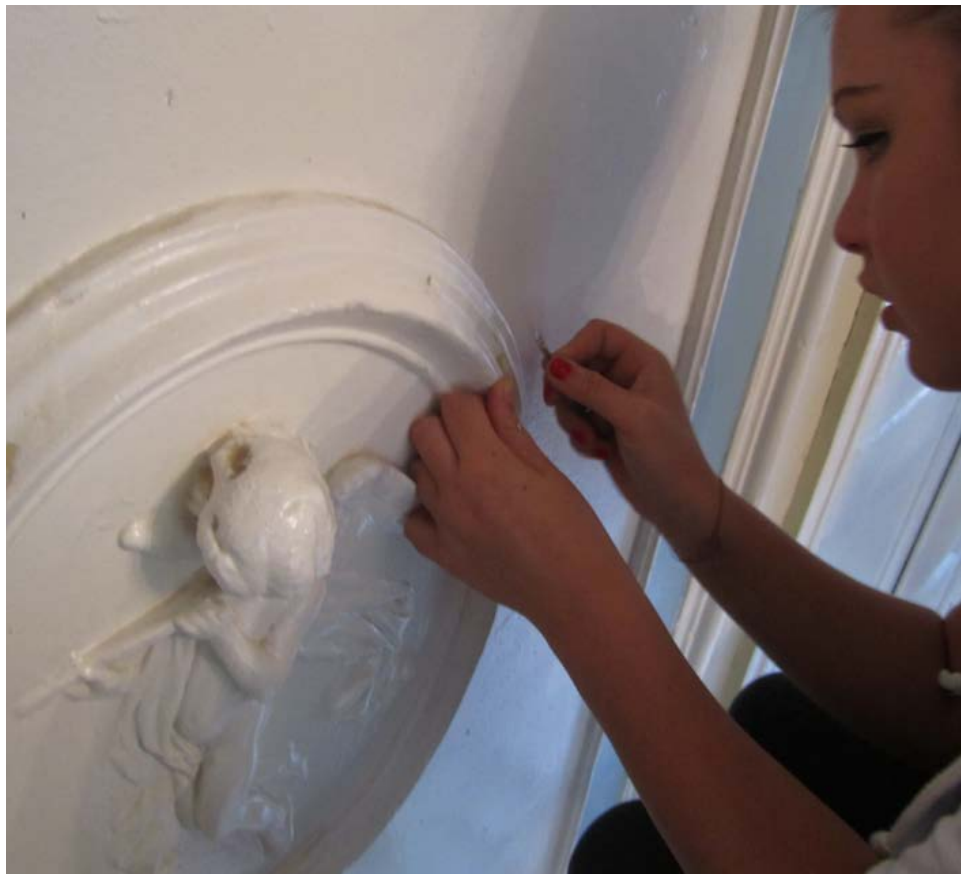
Figure 2.9. The unproportional head can be seen to the left. Photograph by Sandra Heinström.

“The head of the *putto* we worked on was disproportionate and did not harmonize with the rest of the body. Here it looked like a repairman had taken a head from somewhere else and just attached it with no regards to aesthetical values. It looked just horrible and was removed. A mould was taken from one of the intact *putti* and a new head was cast with a mixture of plaster and glue. The glue acted as a bonding agent and reinforced the plaster.

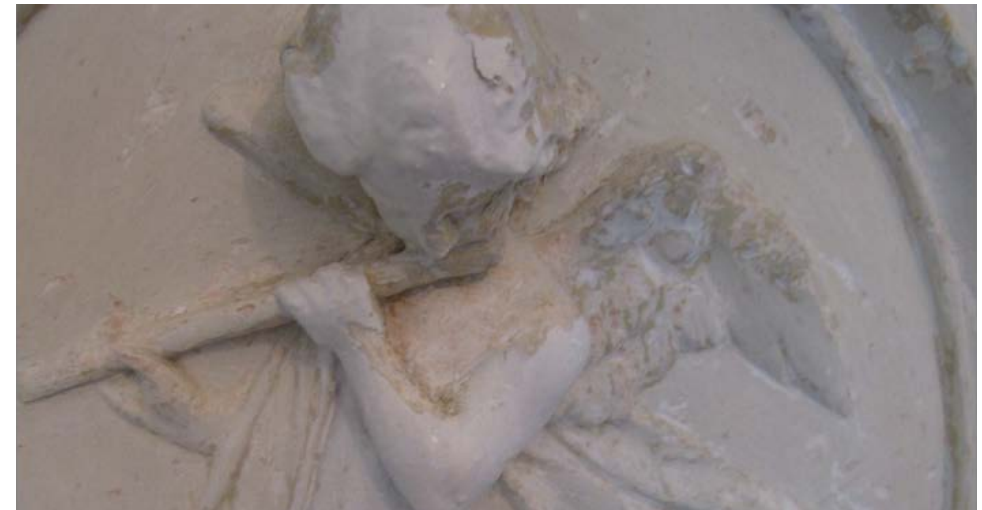
Figure 2.10. This *putto* had not only lost his original head but also hurt his wing. Photograph by Sandra Heinström.

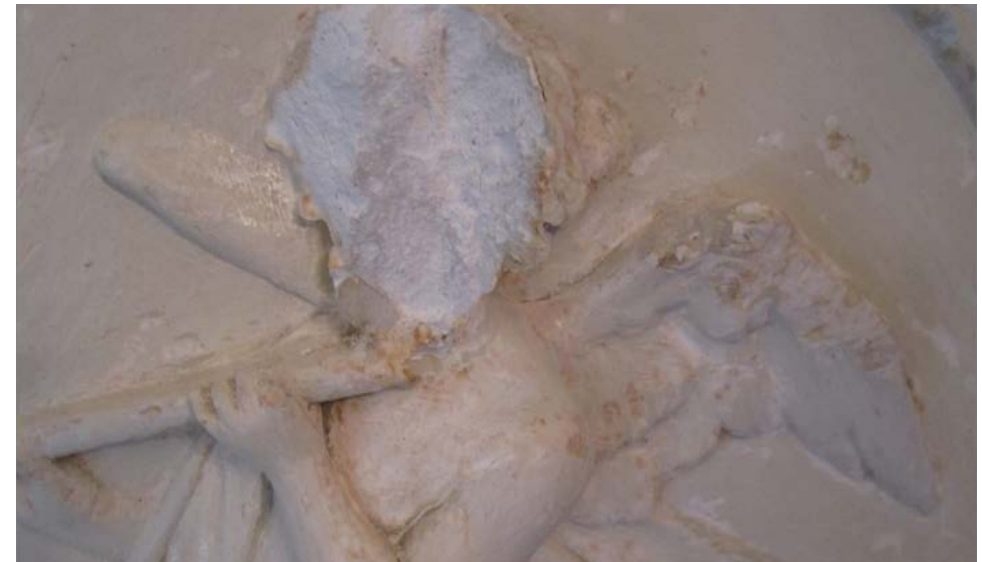
Figure 2.11. He was decapitated again... Photograph by Sandra Heinström.

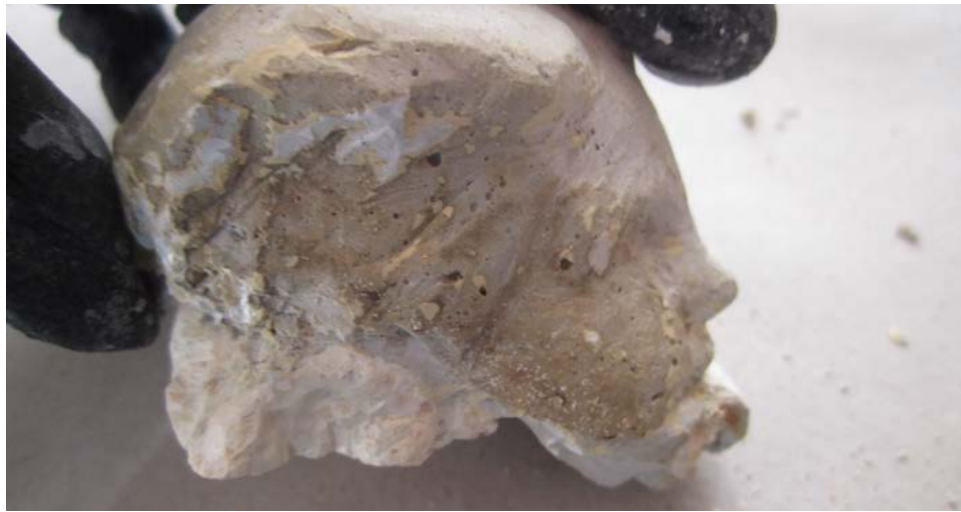
Figure 2.12. A bad cast of bad quality plaster was revealed underneath the paint. Photograph by Sandra Heinström.

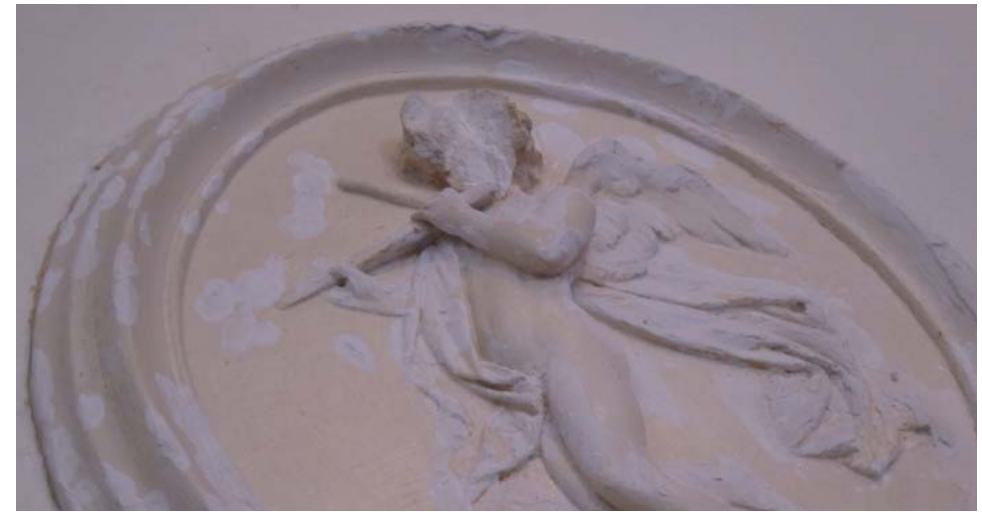
Figure 2.14. While a new head was being made the rest of the defects were repaired with gypsum plaster which was then sanded down. Photograph by Sandra Heinström.

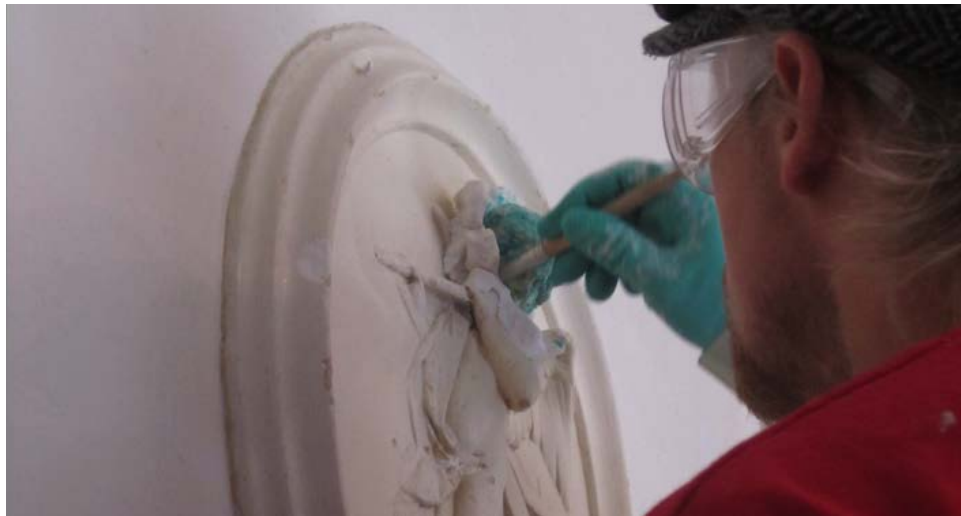
Figure 2.13. Luckily there was another flute playing *putto* in the room. Heiti Kulmar is building up the mould layer by layer. The plasticine is there to cover the intact *putto* from droppings. Photograph by Sandra Heinström.

The method for taking a mould was by first cleaning the existing original thoroughly. This involved removing all paint layers except the one that we presumed was the original one, repairing defects with plaster and applying a release agent on the piece. The release agent is just what the name suggests; a chemical that forms a film on the surface of the original, and it acts both as a protector from the mould material and enables the release of the mould material. We had access to two types of mould material. Both of these consisted of a two-component silicone, one of which cured very rapidly and the other gave a little more working time. These were applied using a sponge and a brush. Many batches had to be made to cover up the head as the mould was created slowly in layers in order not to waste any silicone and to make sure that

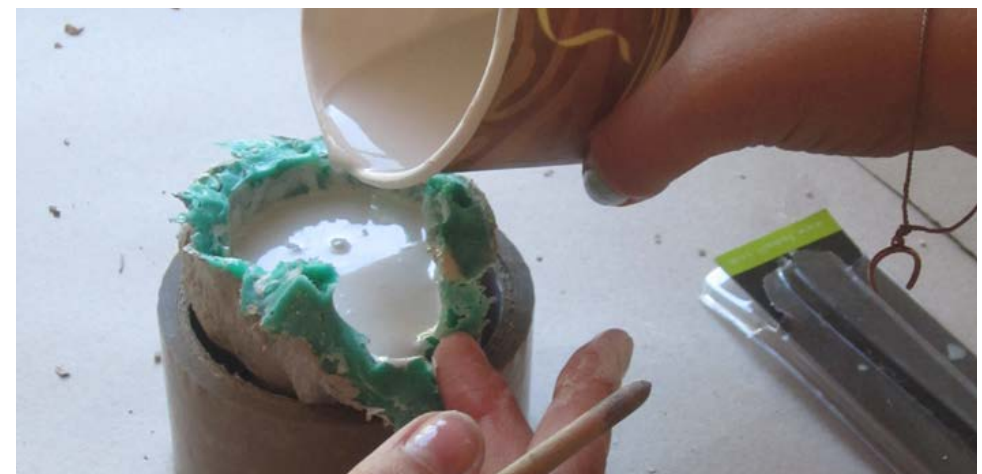
Figure 2.15. The silicone was stiffened with a crust of gypsum before it was taken off the model. Here a new head is in the making. Photograph by Sandra Heinström.

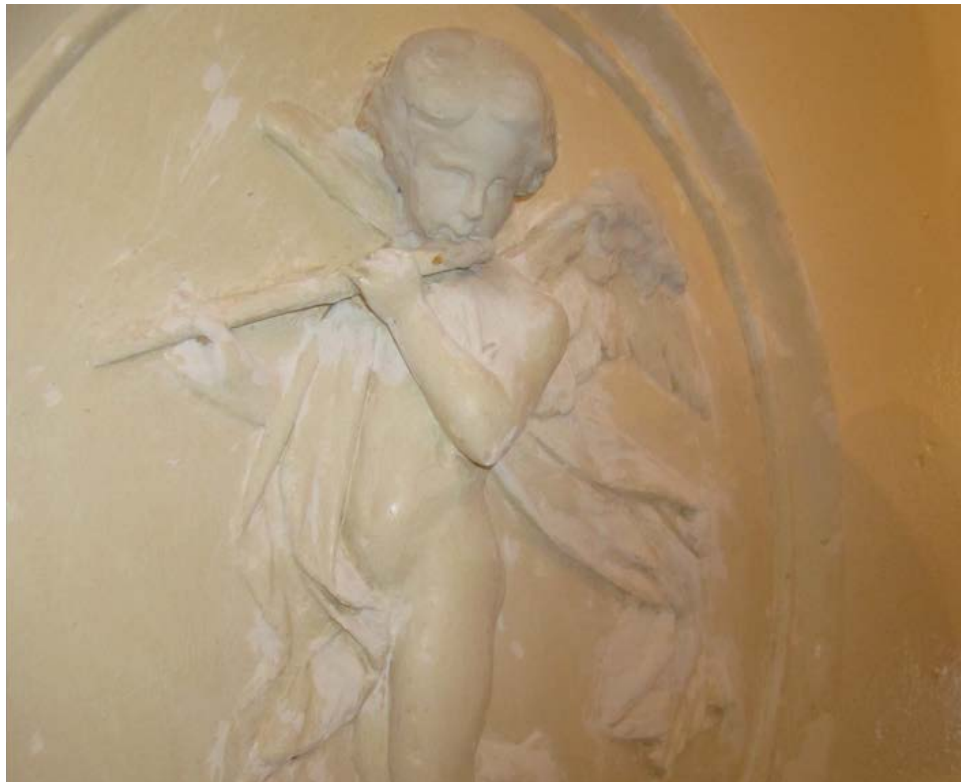
Figure 2.16. The new head in place! Photograph by Sandra Heinström.

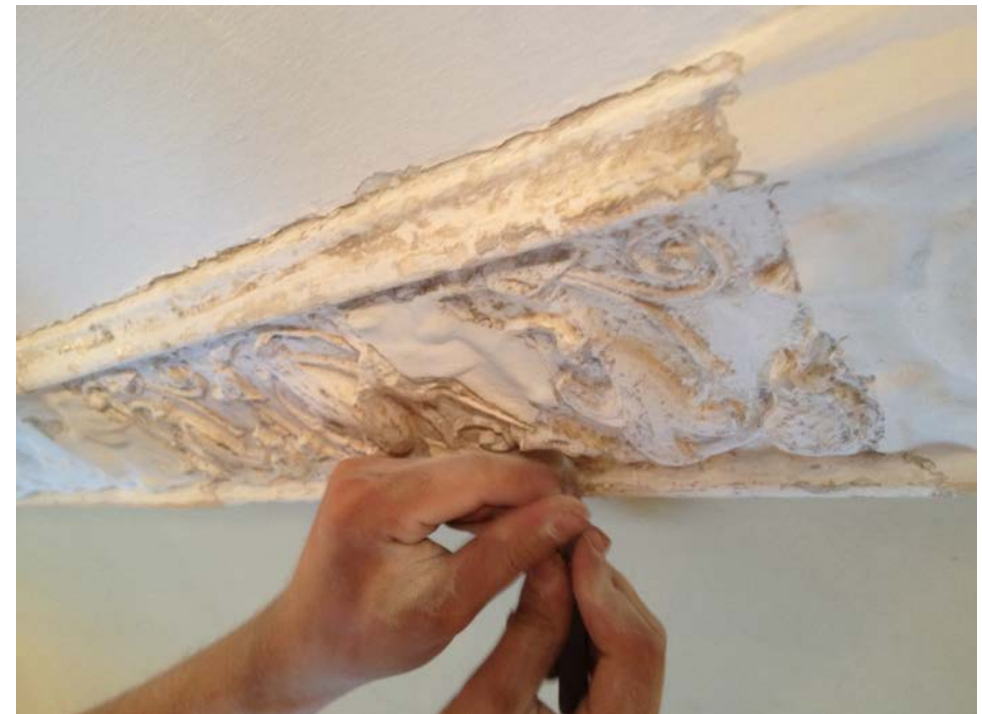
Figure 2.17. Working through many coats of paint. Photograph by Liv Berntsson.

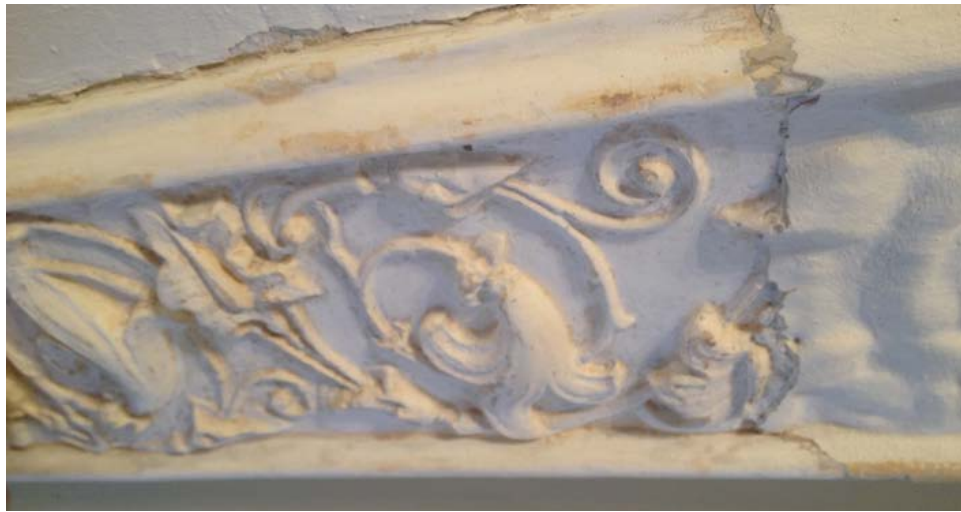
Figure 2.18. The delicate original shapes are not recognizable through the many coats of paint on the right. Photograph by Liv Berntsson.

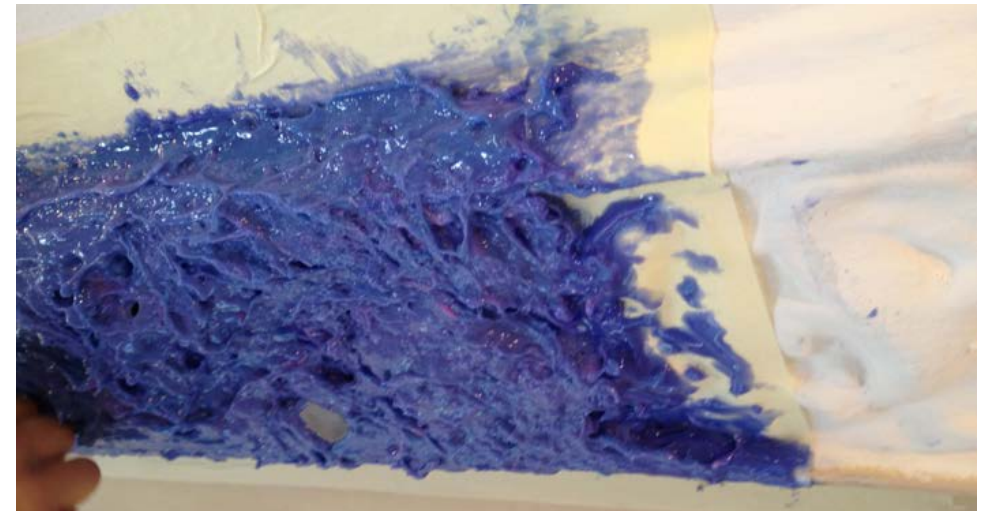
Figure 2.20. The silicone mould was built up layer by layer.

“In the making of the cornice moulds, the same method as for the *putto* was used. The bad piece was first removed and a section of pristine cornice from elsewhere in the room was selected to act as the original. It was revealed from paint and cleaned by brushing, and small nicks were repaired with plaster and then sanded down in order to get a smooth surface with as many details and few defects as possible. A release agent was applied on it followed by silicone in stages. Once everything had cured properly, a supporting shell of plaster bandages was applied just like in the case with the *putto*

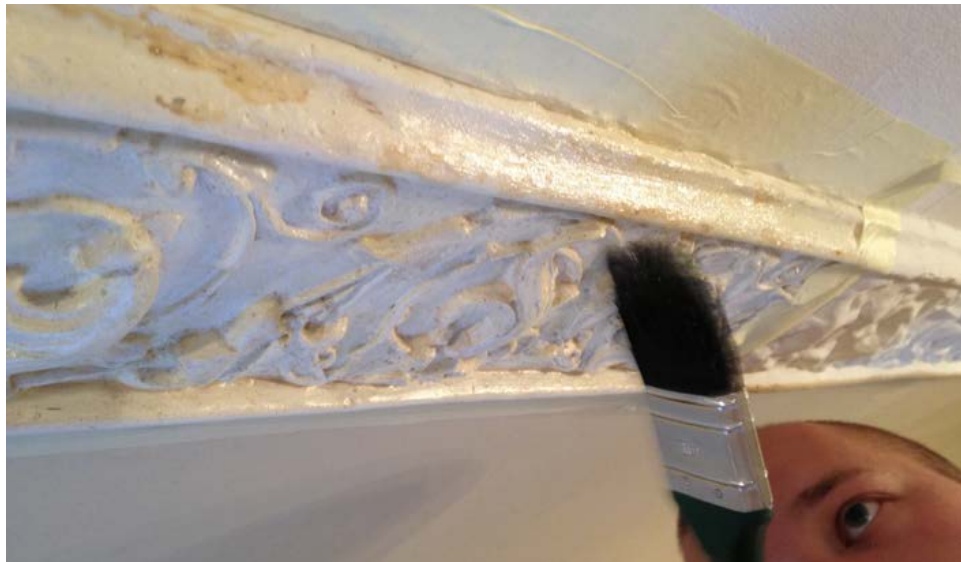
Figure 2.19. The original was touched up with gypsum plaster, sanded and brushed clean to give a perfect mould. Photograph by Liv Berntsson.

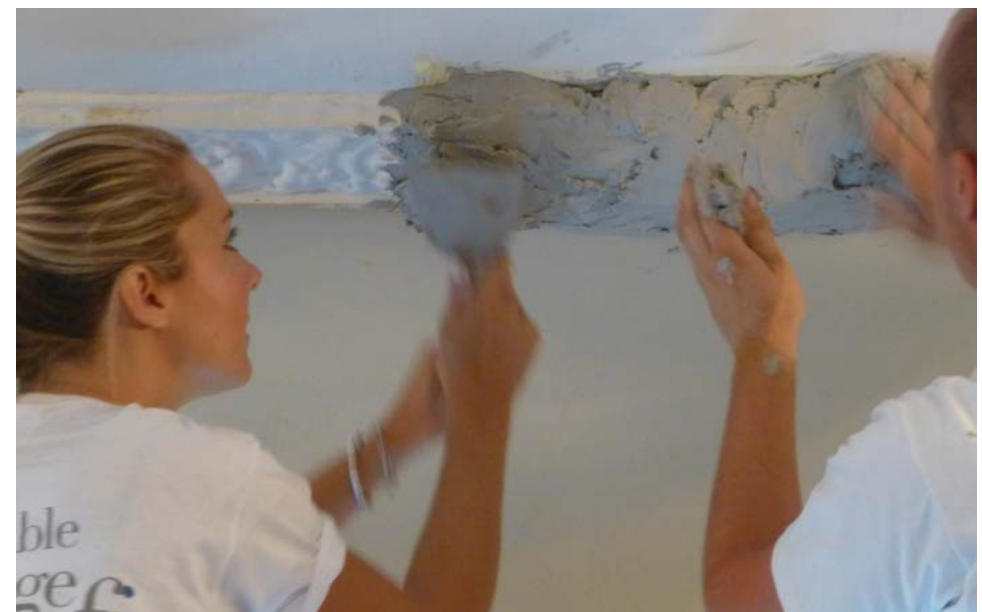
Figure 2.21. The silicone was covered with plaster and the whole package was left to dry. Photograph by Kirsti Horn.

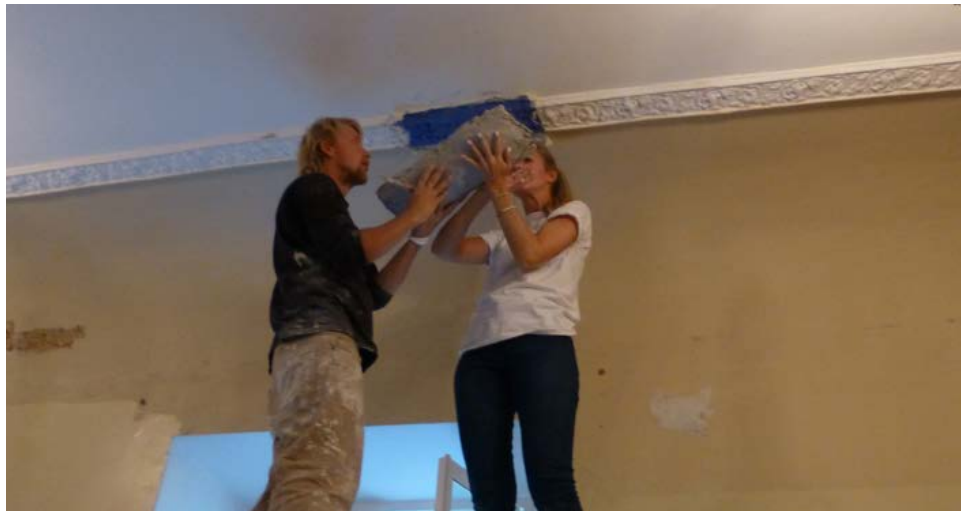
Figure 2.22. The moulds were taken down the next day. Photograph by Kirsti Horn.

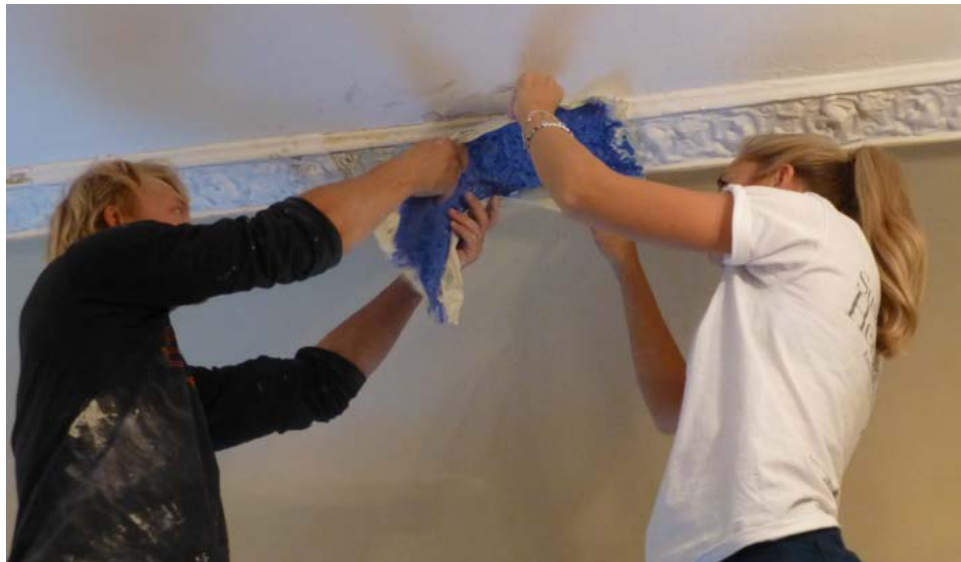
Figure 2.23. Silicone after the gypsum. Photograph by Kirsti Horn.

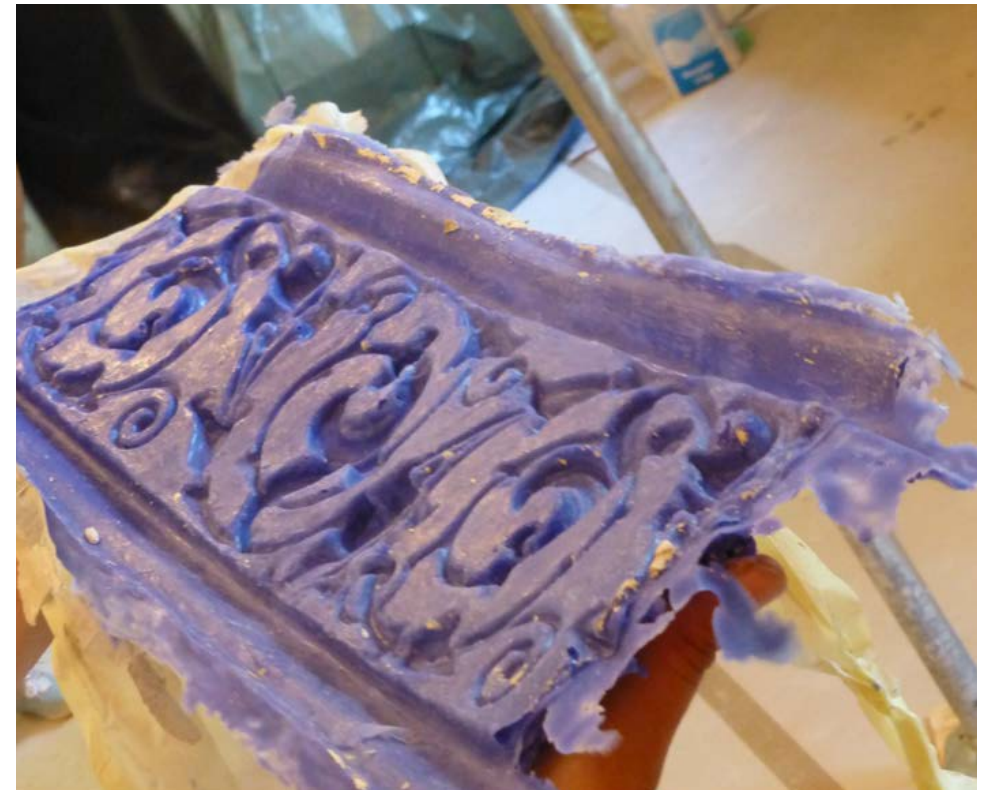
Figure 2.24. The silicone mould is ready to be used. Photograph by Kirsti Horn.

Silicone was used because of its excellent properties in retaining details from the original and its ability to resist plastic deformation. Both of these properties are very sought after in a good mould material because the silicone can fill voids, take shape overhangs and cover three dimensional shapes easily. When removed from the original it can be stretched without tearing and then return to its original form. This is why silicone is widely used in reconstructing stucco.”

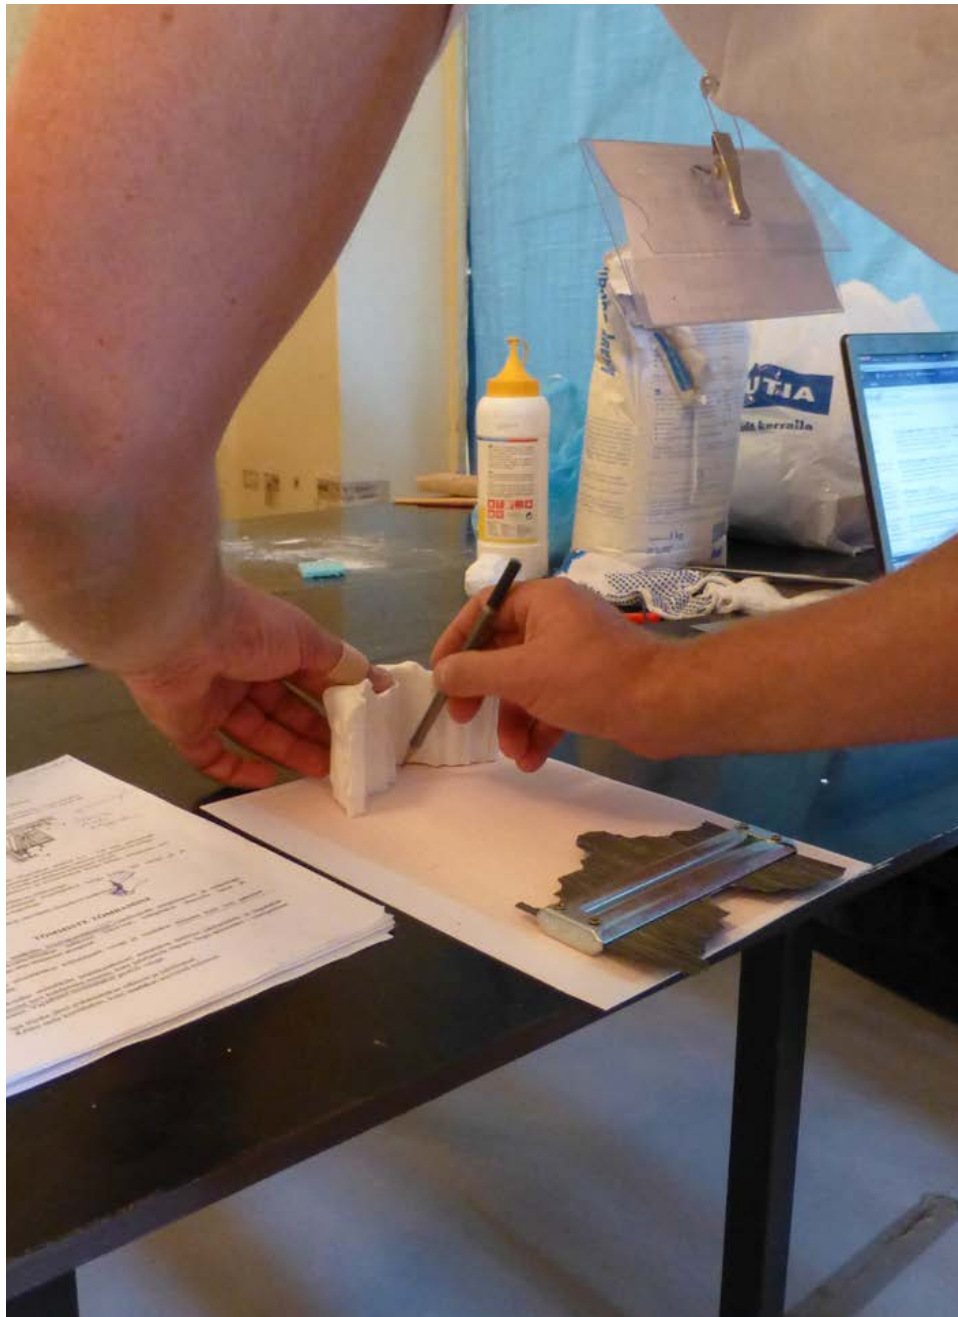
Figure 2.25. The desired moulding was documented by using plasticine and a profile comb. Photograph by Kirsti Horn.

A lump of plasticine or a profile comb should be used to copy the shape of the moulding that is to be reconstructed. Both were tested when a copy of a moulding in the ballroom was manufactured. The new moulding was run on a table with the help of a mould on a sledge. This can be done directly on a wall or ceiling as well. For making the mould and the sledge, an angle, a compass saw, metal shears, a knife, a pen, an electric drill and circular saw were used.

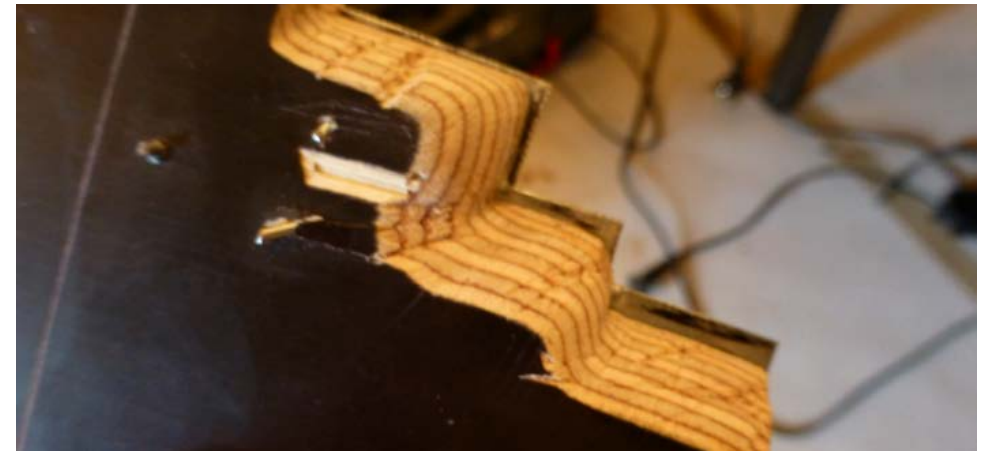
Figure 2.26. The documented moulding profile was transferred on metal sheeting and cut precisely in this shape. A piece of plywood was shaped accordingly and then attached to one side of the metal sheet. Photograph by Kirsti Horn.

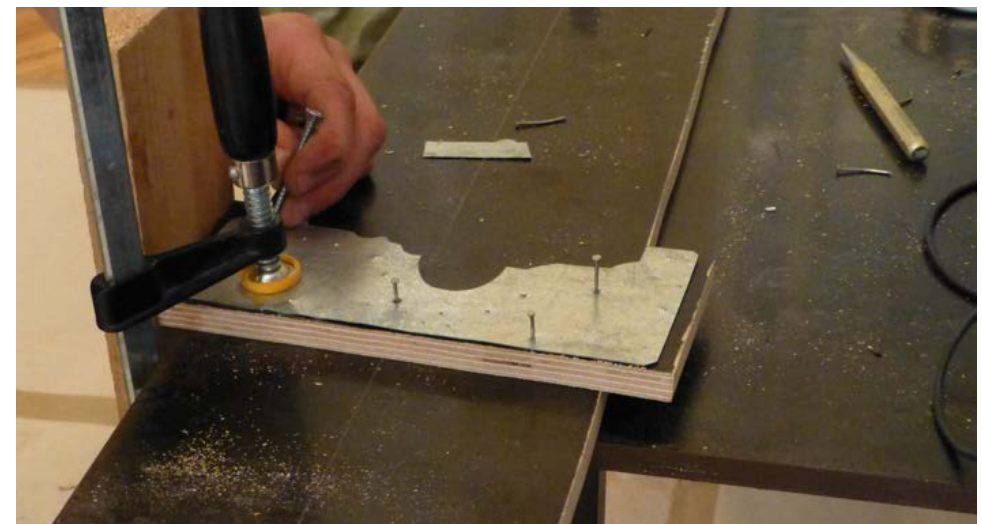
Figure 2.27. A sledge was built to hold the stencil upright. Photograph by Kirsti Horn.

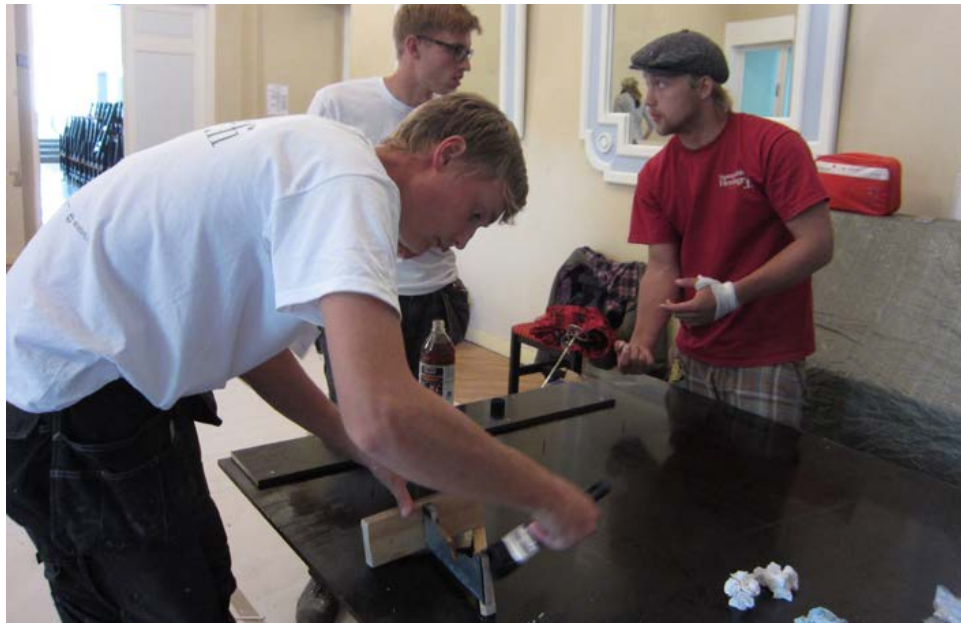
Figure 2.28. A wooden rail was attached along one side of the working table. The table and mould were oiled to start with. Photograph by Meelike Naris.

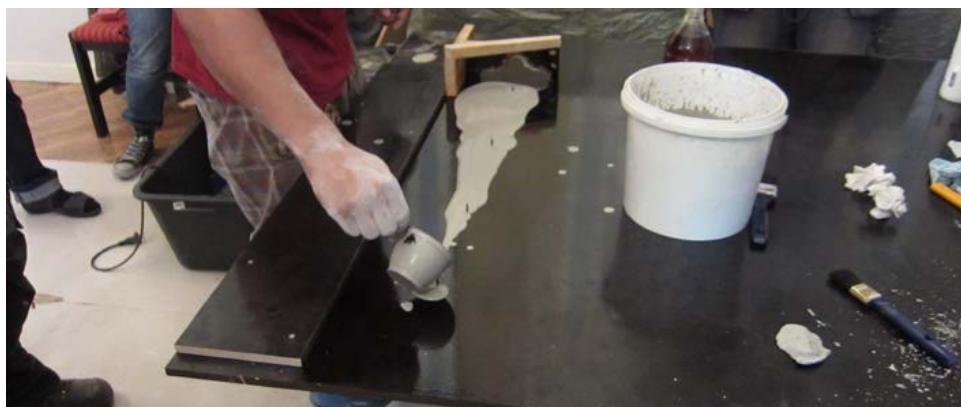
Figure 2.29. Plaster was mixed using a whisk and then poured on the table. The moulding sledge was pushed with metal side first to shape the plaster. Photograph by Meelike Naris.
