Decorative Plasterwork at Volvveti Manor

—Sustainable Heritage Report No. 6

Traditional Wooden and Masonry Structures in the Baltic Sea Region
Sustainable Heritage reports, 2/2014

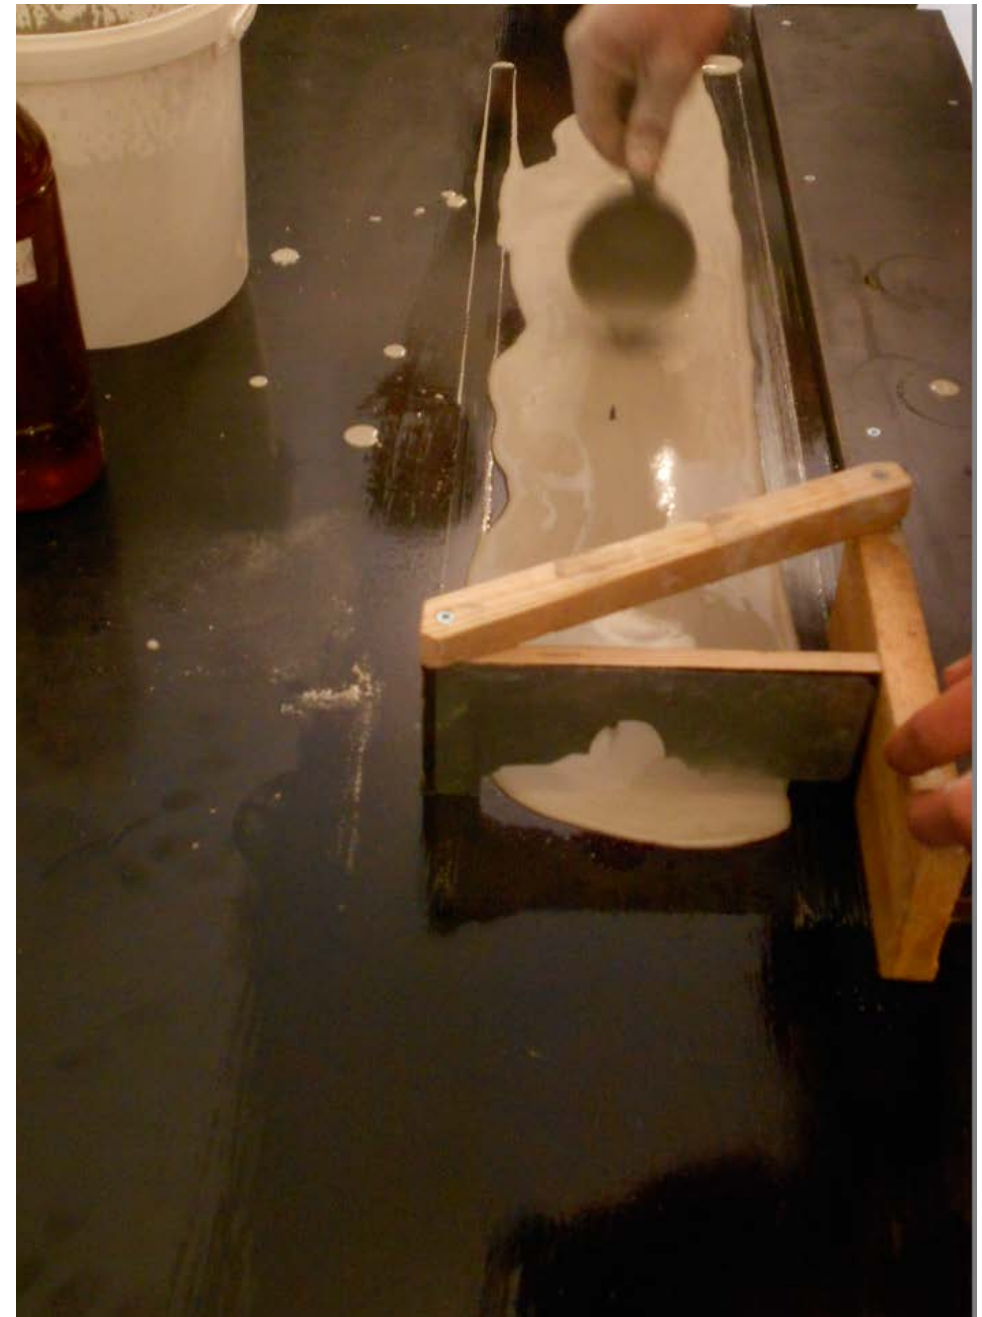
Figure 2.30. More and more plaster was added, repeated pushing, more plaster etc. until the shape was complete.

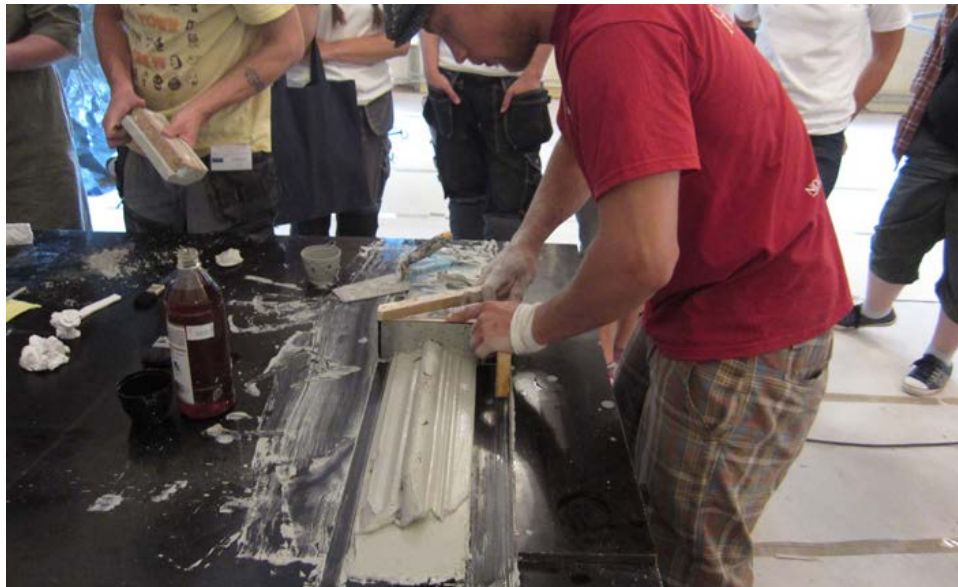
Figure 2.31. Heiti Kulmar is showing the technique. Photograph by Meelike Naris.

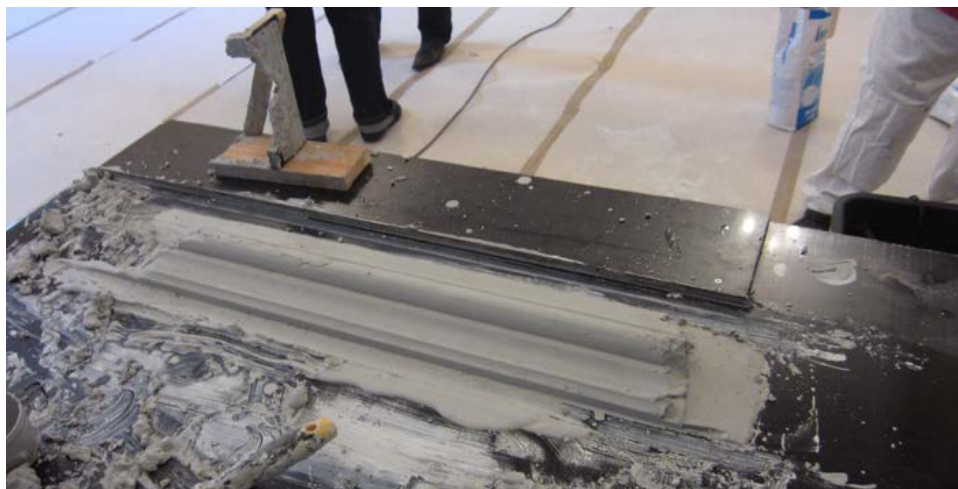
Figure 2.32. After the moulding was complete, the piece had to be trimmed still with a rasp, a scalpel and sandpaper grade 80–800. Photograph by Meelike Naris.

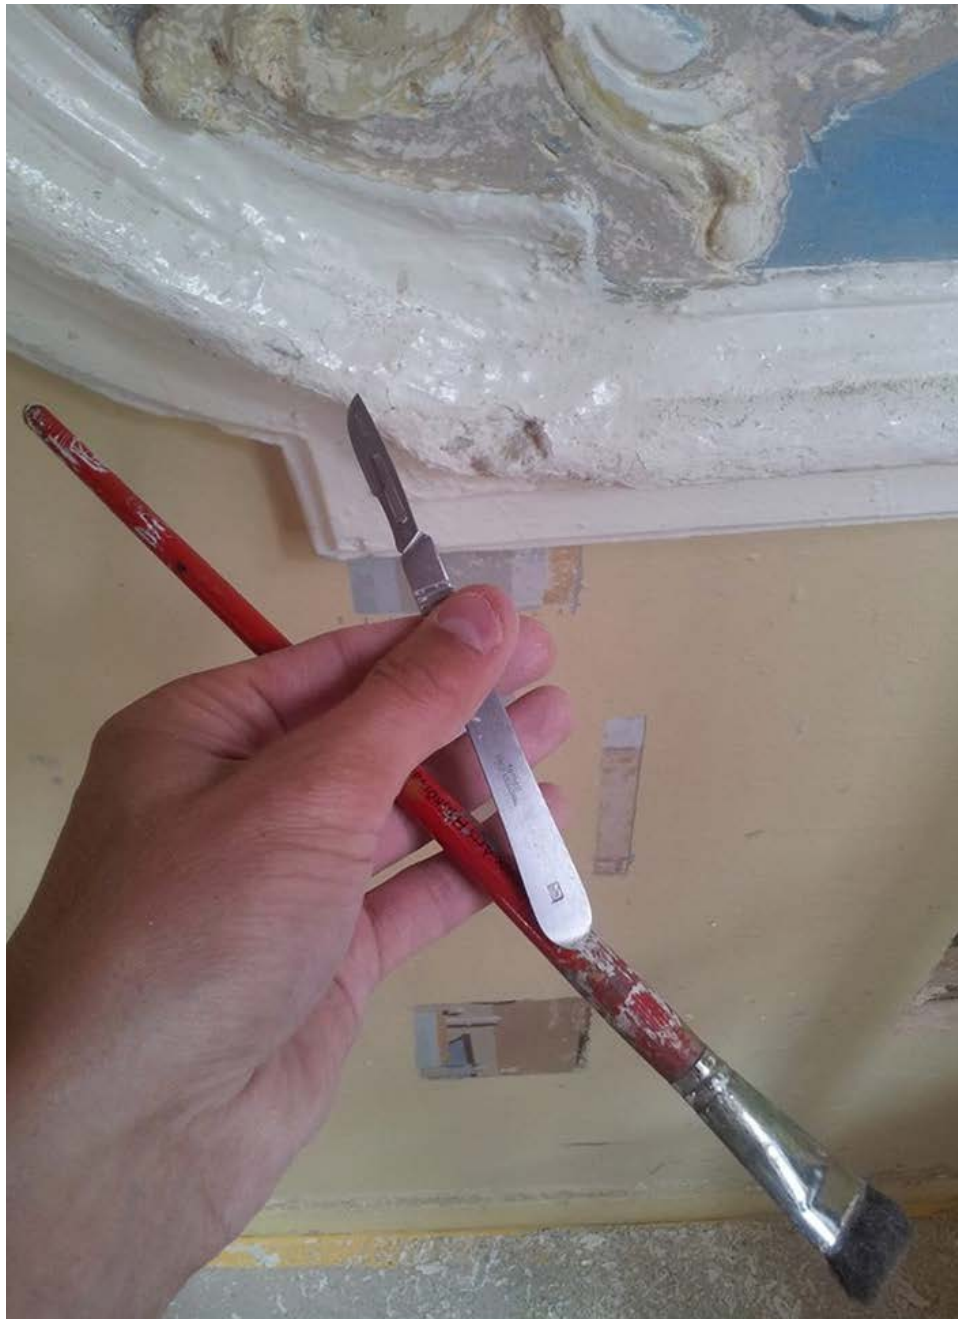
Figure 2.33. Tools for cleaning. Photograph by Lars Eriksson.

As a tool I was using a scalpel with exchangeable blades, which was useful because they kept breaking, and if they didn't, they got blunt. A brush was also useful for removing dust and paint flakes with (figure 2.33). I got instructions to work myself down to the innermost or most original layer of paint, which was of a greyish–white colour and cracked in a quite beautiful way, so I did this. It took a lot of time, as the details were many, and the person beside me, working on the bottom right corner of the same panel, was competing with me for the work space, as did the scaffoldings, and a person working above me caused a steady snowfall of flakes down on me, which made the work situation somewhat problematic.

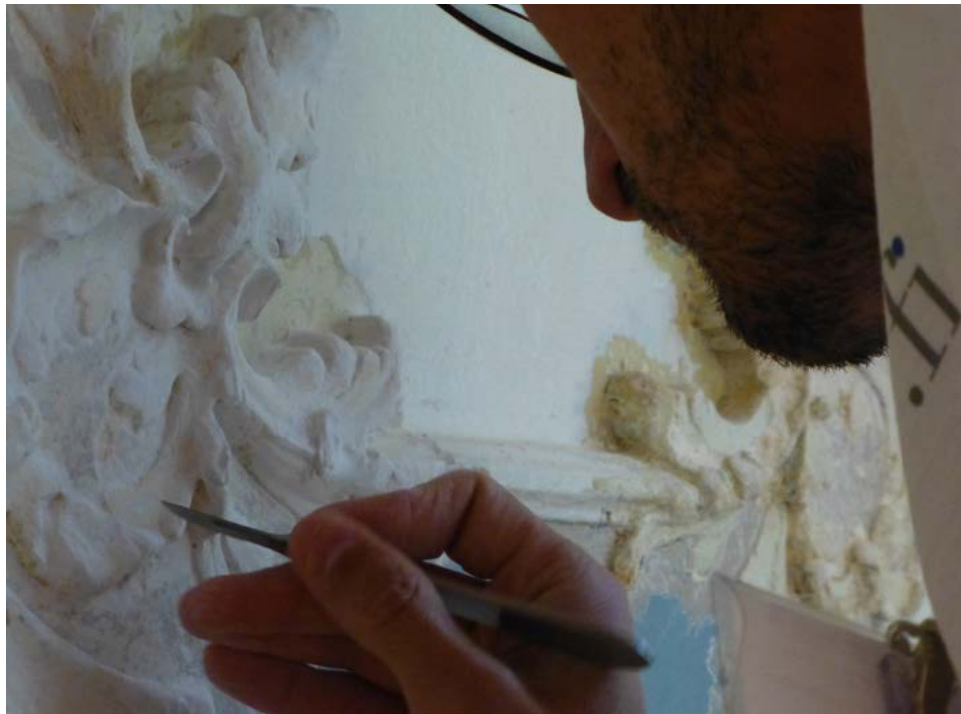
Figure 2.34. It took a whole week to clean and repair one acanthus motif.
Photograph by Kirsti Horn.

It was very difficult to remove layers of paint from the stucco without destroying details in the ornament. When I finished the cleaning job, it was time to reconstruct the missing details (most of them were already missing, before I started with the cleaning). I also discovered old repairs made in different materials. They were mostly fragile so I took most of them away. I discovered small flies that once had got caught in the fresh paint. I cleaned the whole thing free of dust and made a mixture for repairing, which I applied, sometimes in several layers, to build up lost forms. Then I made new forms with my scalpel (figure 2.34), inspired by the many other acanthus motifs in the room, which I studied closely. The last thing I did was to use a fine sandpaper, finally an even finer one, to make a nice finish.”
